# Diagnostic and repair of sewage treatment plant tanks in Žilina

DOI: 10.15199/33.2017.07.18

(Studium przypadku)

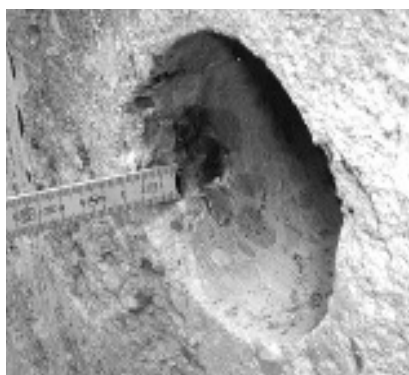
**Photo 2. Measurement of carbonation depth of concrete on the construction**  
*Fot. 2. Pomiar głębokości karbonatyzacji betonu w konstrukcji*

Determination of the depth of carbonation of concrete was made on the external walls and on the bottom of the tanks in the places of drilled cores. Before assessment the depth of carbonation in each hole after drilled core, a part concrete was lopped (in the direction to the inside of the hole) in order to obtain of concrete in the fresh fracture area. Carbonation of concrete was determined by a simple indicating method, by moistening of concrete with phenolphthalein (0.1% solution in ethanol) [6]. The results of the measurements indicate that the depth of carbonation, at all the tested locations of the reinforced concrete structures, do not reach main and distribution reinforcement. It means that until now there is no risk of the corrosion of re-

inforcement, which is caused by carbonation of concrete.

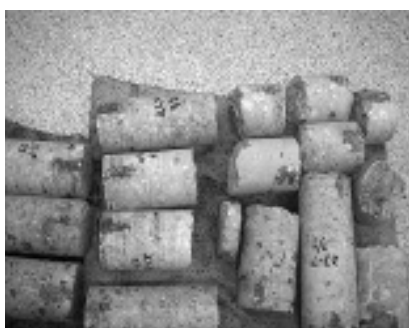
**Photo 3. Measurement in the laboratory on the drilled core samples**  
*Fot. 3. Pomiar w laboratorium na odwiertach rdzeniowych*

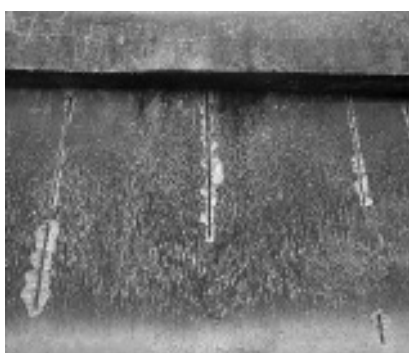
Engineering in the University of Žilina), was to determinate of the depth of carbonation of concrete in the construction and also it was measured in the laboratory on the drilled core samples (Photo 2, 3). Another measured parameters, were diameters and type of reinforcements, corrosion of reinforcement, concrete cover and location of reinforcement (Photo 4, 5).

**Photo 4. Corrosion of reinforcement**  
*Fot. 4. Korozja zbrojenia*

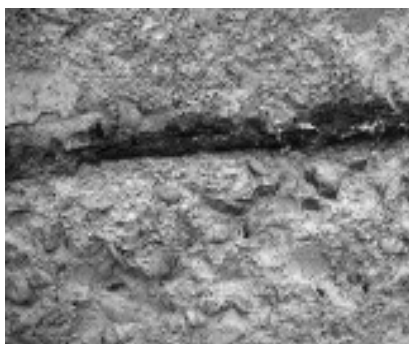
**Photo 5. Detail of reinforcement corrosion**  
*Fot. 5. Szczegóły korozji zbrojenia*

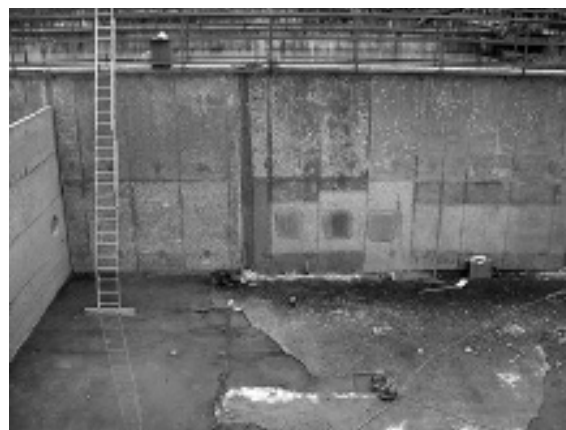
The concrete cover and corrosion of reinforcement was determined in those places on the walls and on the bottom of reinforced concrete tanks, where the reinforcement is exposed after drilled cores. In these places were not found the reinforcement corrosion. In same places, only surface corrosion was detected, which was caused by the effects of atmospheric moisture by drilled cores. Reinforcement corrosion loss was detected on the place where the concrete cover was dropped out. The reinforcement surface corrosion of distribution reinforcement (type of bar is smooth rough bar of 12 mm diameter) was found on the longitudinal reinforcement and inside walls of the tank (SO 100-09 Activation tank, Photo 6)

**Photo 6. SO 100-09 Activation tank**  
*Fot. 6. Zbiornik aktywacyjny SO 100-09*

on the places where the concrete cover was dropped out. The maximum value of corrosion decrease was 0.5 mm. The reinforcement corrosion of main reinforcement (steel grades B 420B of 14 mm diameter) was found above the working surface of the water on the walls of SO 100-05 Settling tank on the places where the concrete cover was dropped out. The maximum value of corrosion decrease was 3.0 mm. In other places and other building objects the concrete cover was not dropped out.

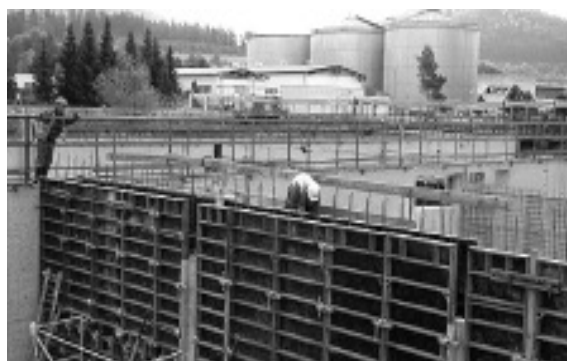
**Photo 7. Rehabilitation of SO 100-09 Activation tank**  
Fot. 7. Odbudowa zbiornika aktywacyjnego SO 100-09

On the base of diagnostic results, there were recommended rehabilitation arrangements, which subsequently were realized. The whole circumferential walls of the SO 100-09 Activation tank was needed to strengthen with a new reinforced concrete layer and on the bottom of the tanks was applied a suitable materials for rehabilitation (Photo 7).
