# Failure of a reinforced concrete silo – reconstruction project using elements of BIM technology

**Abstract.** The article describes a case study of a failure of reinforced concrete ceiling of a rapeseed meal silo. The causes and extent of damage are discussed. On the basis of BIM technology (*Building Information Modelling*) the main elements of the project of reconstruction of silo's structure are presented, including disassembly of the damaged part and making a new one.

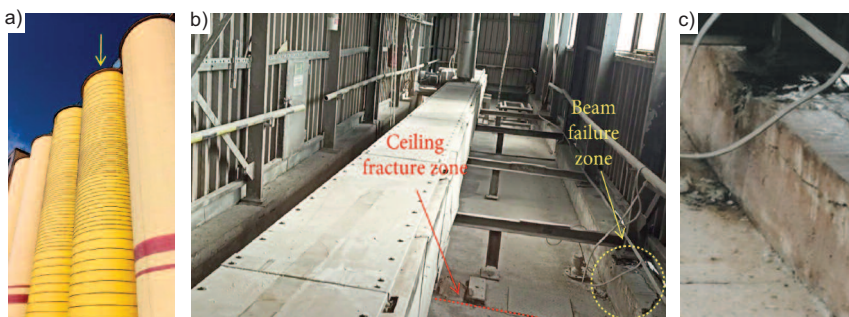
**Silo battery:** a) general view with indication of chamber failure; b) ceiling damage; c) crushing of concrete in a beam

During the use of one of the chambers of the silo, a failure of the ceiling structure occurred (Photo 1). The failure involved a crack in the ceiling slab (Photo 1b) and crushing the compression zone of concrete in the span of the beam (Photos 1b and 1c). As a result of significant deformation, the connection between the column of the gallery and the beam was lost. Due to safety reasons, no visual inspection of the beams was conducted on the inside of the chamber, so the extent of damages in the stretch zone of the beams remained unknown.

The direct cause of the failure was the spontaneous collapse of the arch of rape-seed meal, which caused a negative pressure with a vertical force directed towards the bottom of the chamber (in spite of the existing ventilation stacks). As a result of the emerging load, the bearing capacity of the ceiling was exceeded. The arch effect in silos may take the form of either overhang or arches that cause significant negative pressure at the moment of spontaneous or induced detachment [4, 5]. This is caused by the fact that, after the collapse of the arch, the volume of air in the space under the ceiling of the chamber increases to the end value that equals approximately the total volume of the air above and below the arch prior to the collapse. After some time, the emerging negative pressure equalizes with the atmospheric pressure, provided that the ventilation equipment has been designed and functions correctly. The negative pressure in the part of the silo located under the ceiling is the higher, the more the silo is filled and the higher the arch was located above the discharge hopper. A common cause of the emergence of arches is the caking of the loose material as a result of

The conducted visual inspection revealed a large scale and extent of damages to the ceiling. Repairing and reinforcing

the damaged parts of the structure raised justified doubts in the technical and economic aspect. Hence, it was decided to prepare a design of reconstruction of the ceiling and the gallery. At the first stage, the plan of disassembly of the gallery and the ceiling was developed, followed by the second stage, which was the reconstruction design. The designs were created with the use of BIM solutions that consist in creating 3D models in the Autodesk Revit software. In BIM-supported design, each object is assigned multiple parameters, including material characteristics, geometric properties, and parameters related to the schedule of construction and realisation of the design [1]. Assigning the appropriate scheduling pa-
